*An Archaeological Evaluation of
Samuel Oldknow's Mellor Mill, The Roman Lakes,
Marple Bridge, Stockport*

A report by Peter Noble and Brian Grimsditch
University of Manchester Archaeological Unit
University of Manchester Field Archaeology Centre
Oxford Road
Manchester
M13 9PL
Tel 0161 275 2313
Fax 0161 275 2315
e-mail: peter.noble@manchester.ac.uk
UMAU November 2009

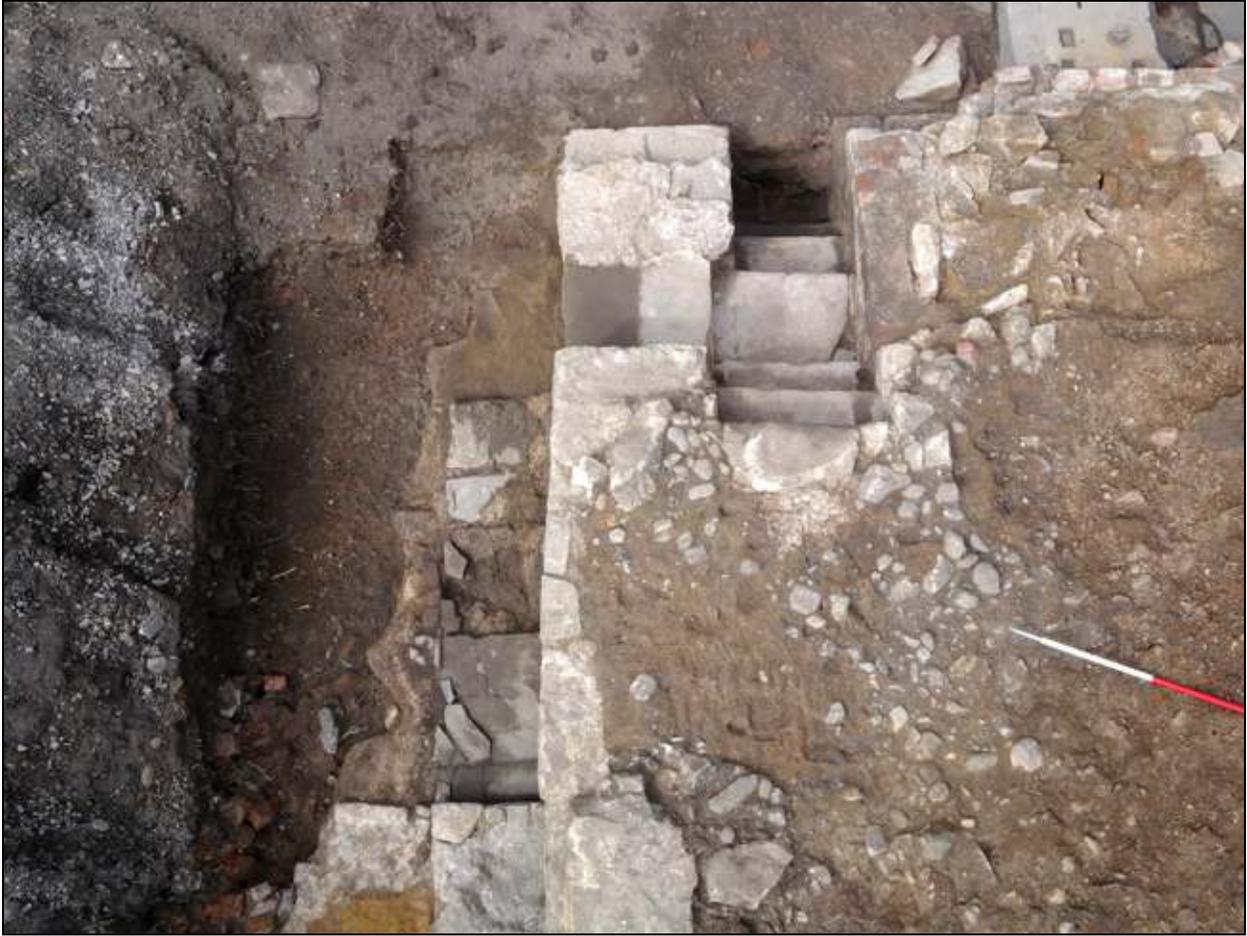
The destructive fire of 1892 and the subsequent ruin and demolition of the Mellor Mill have left both positive and negative archaeological evidence. As to be expected large-scale stone-robbing has taken place over many years and evidence for this was found in both Trench 1 and 2, as well as in the visible remains of the mill outside of the excavation areas. Trench 1 Area B in particular has suffered major stone loss (**Plate 7**).

Plate 7: Overhead showing steps (047), steps (055) and cobbled area (033). Note robbed-out/damaged area (30) to the left. Photo Adam Stanford

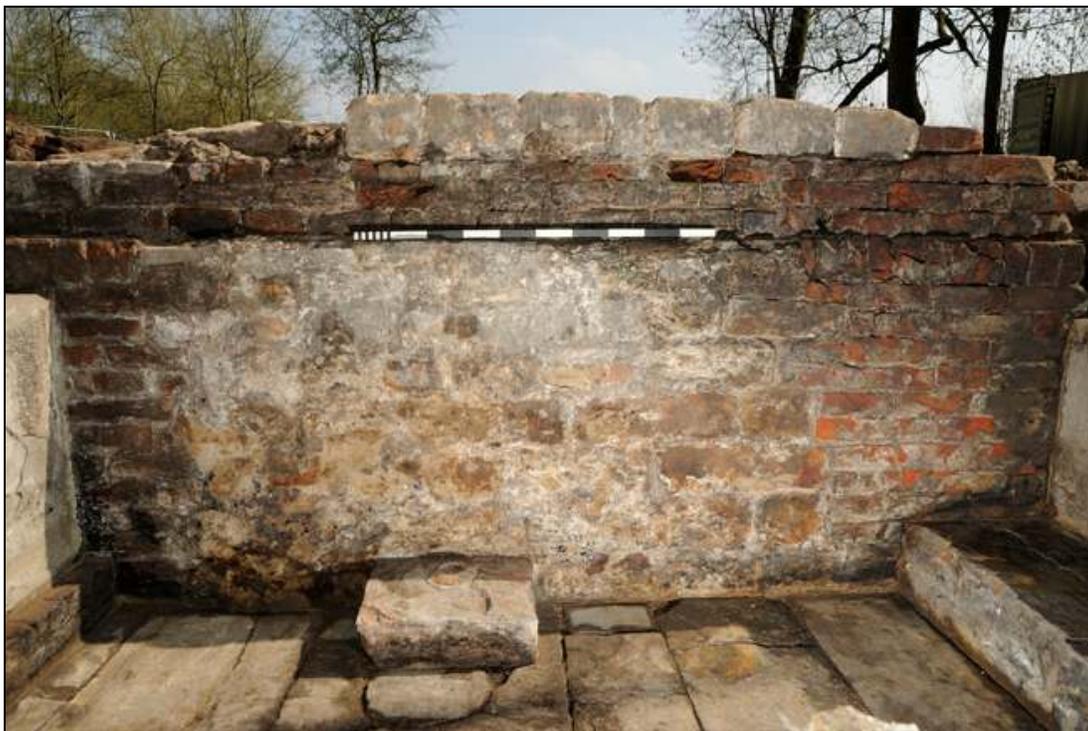
The installation of these beds had necessitated the rebuilding of the mill wall (045) and its replacement with a red brick rebuild (072), as well as the partial demolition of internal basement wall (069). The flooring (040) was also damaged during these works and new flagging was laid which included a small rectangular sandstone plinth (measuring 0.46m by 0.36m) lying centrally between the two machine beds. In the centre of this small plinth (040) were the remains of a small diameter (0.12m) cast iron column.

Plate 10: Area C detail of engine room north facing wall (045) and red brick rebuild (072) with (040) in the foreground. Photo Adam Stanford

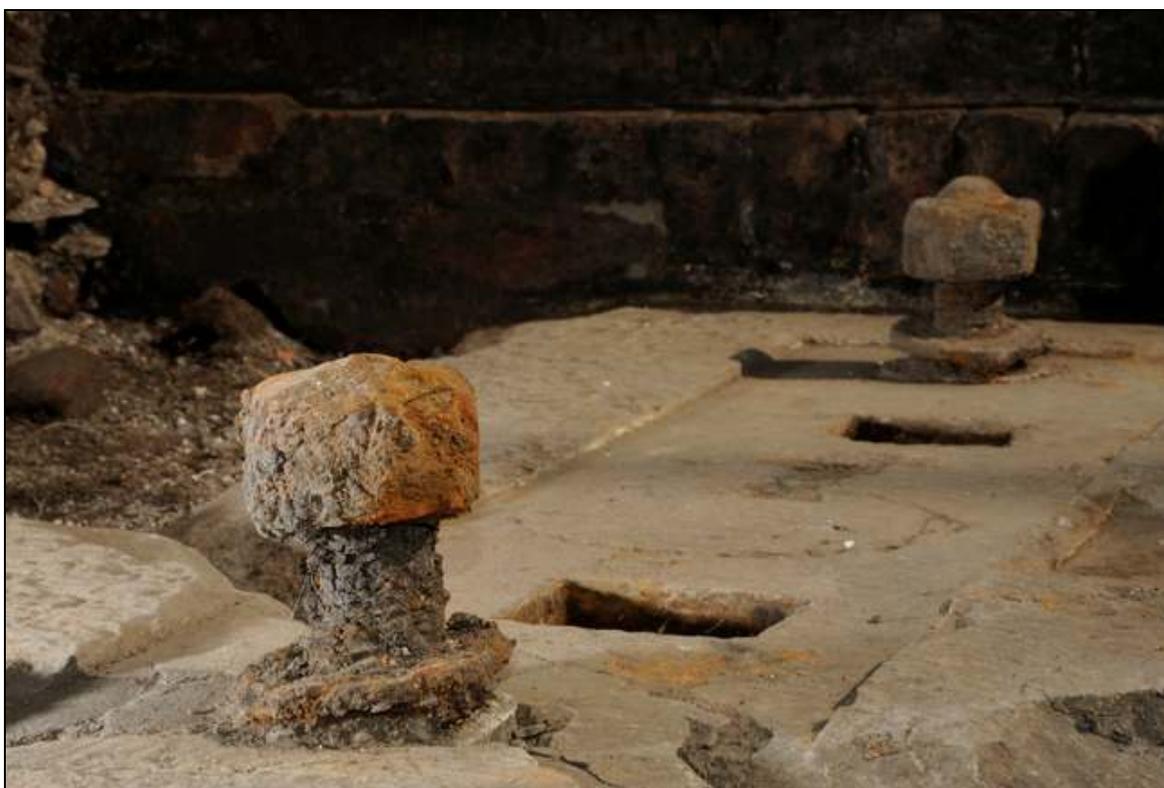
Plate 12: Detail of engine bolts in engine bed (037) Area C. Photo Adam Stanford

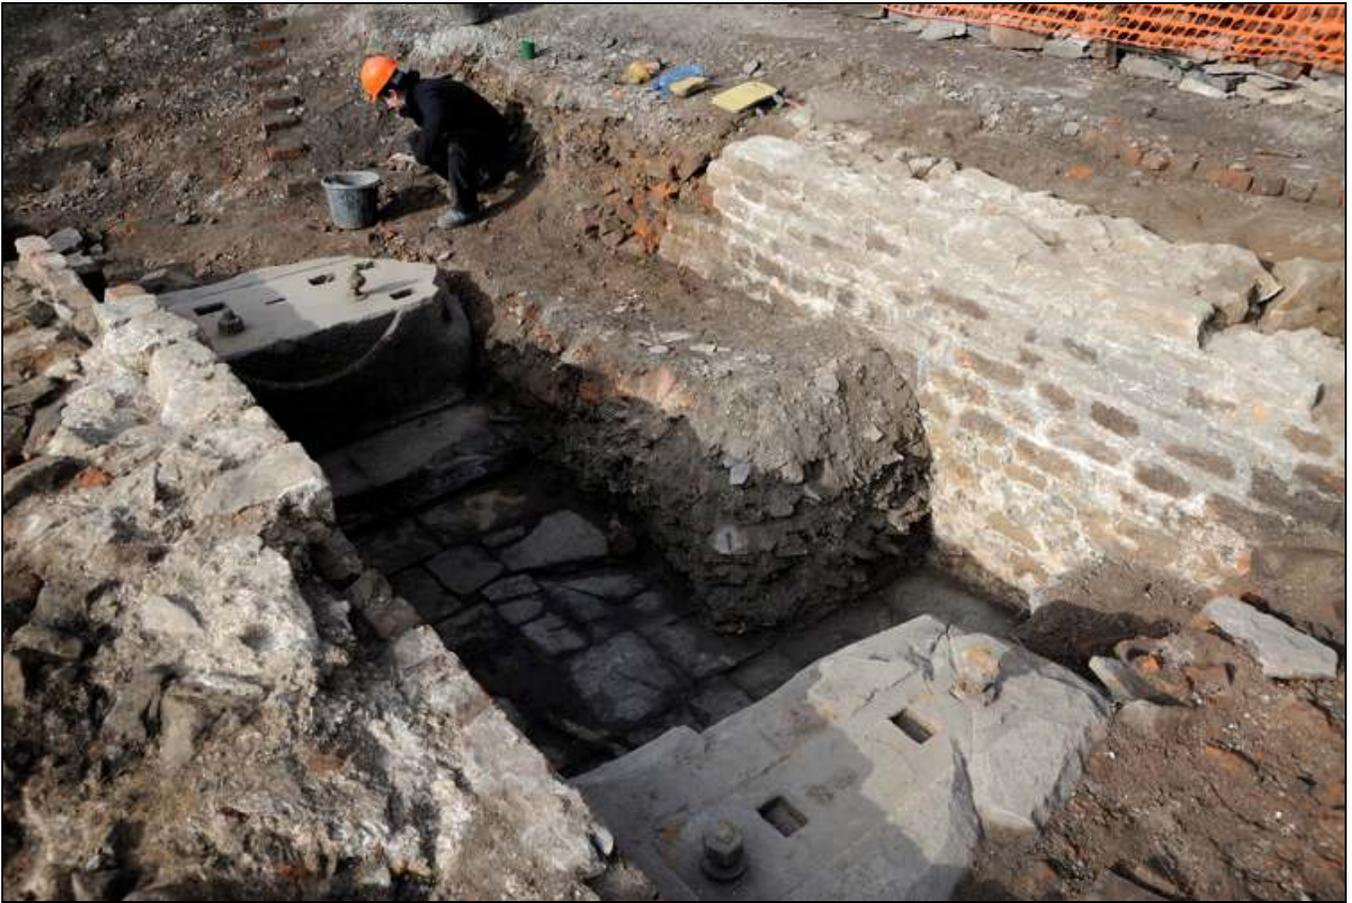
Plate 14: Area C viewed from the southeast. Showing engine beds (037) and (041), floor (039), infill (036) and wall (069). Note break in wall (069) to right of figure

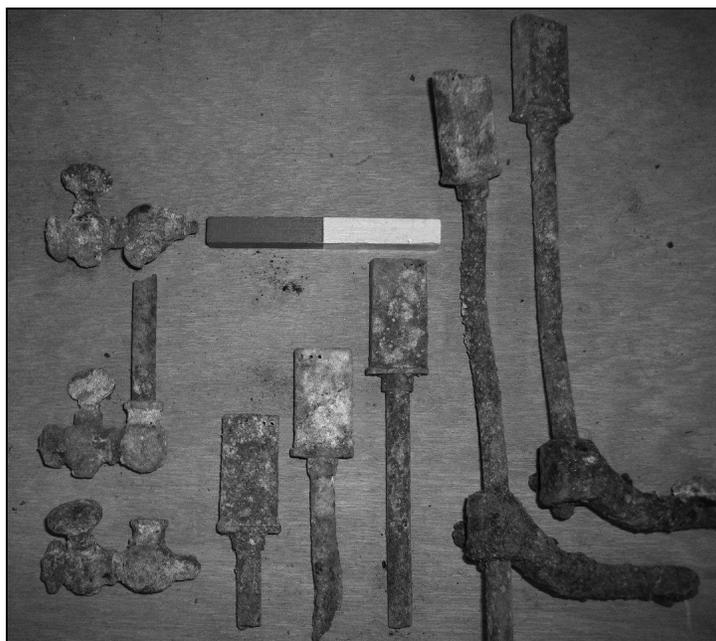
Plate 2 Gas Burners, taps and piping from the excavation

These burners are fed with coal gas and take in air for combustion local to the burner (much like a modern gas cooker). They are very similar to burners shown by Dobson & Barlow in Plate 3.

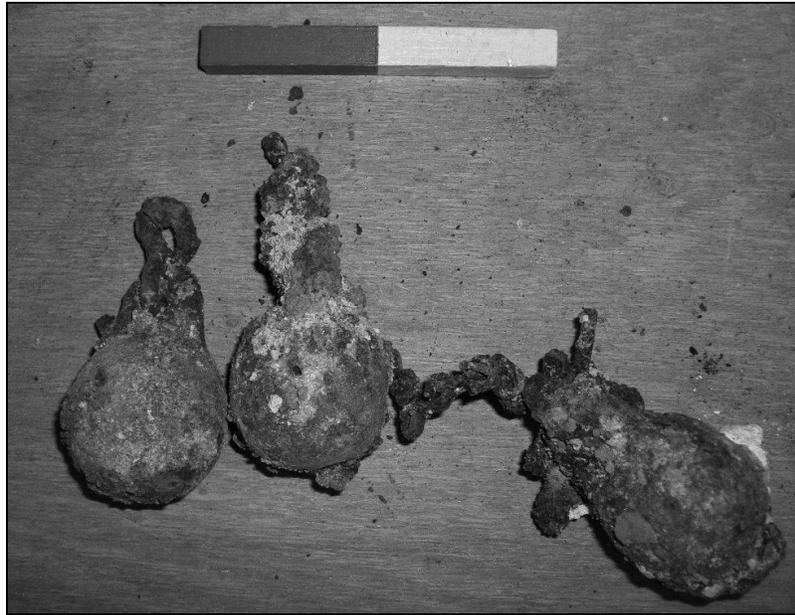
Quite a number of small iron weights (Plate 7) were excavated and compare well with the weights shown in Plates 5 & 6 on the Asa Lees Gassing Frame.

Plate 7 Weights and chains from excavation

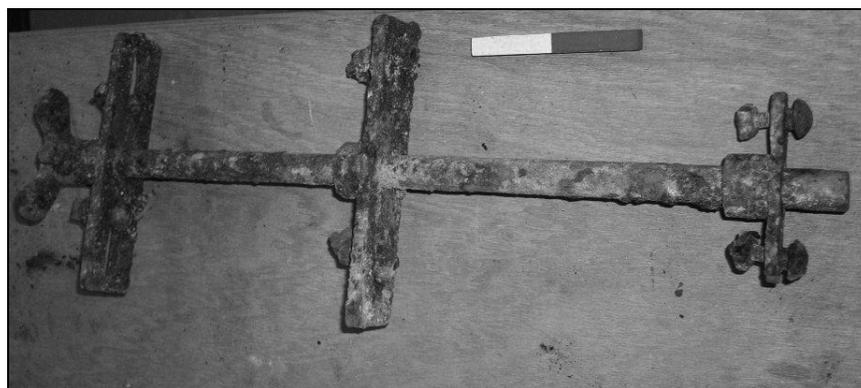
From the excavation there was a total absence of substantial pieces of cast iron machine frame, and very few smaller pieces of such frames. The single largest piece of recovered iron measured about 750mm x 300mm (Plate 10).

Plate 10 The largest single piece of iron found in excavation

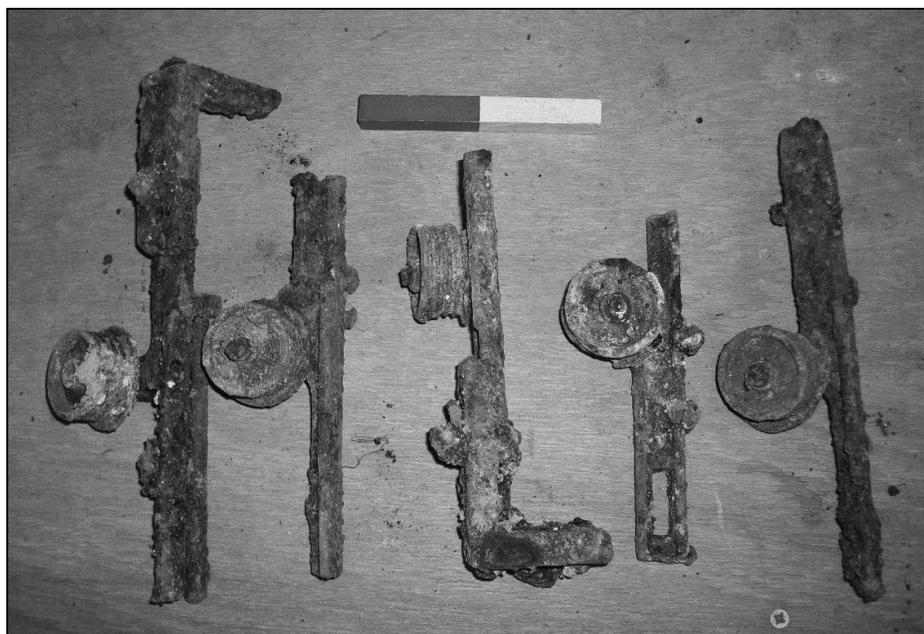
Other surviving components are numbers of grooved brass wheels approximately 30mm (1.25 inches) in diameter, some still attached to broken cast-iron arms (Plate 11).

Plate 11 Brass yarn guides still attached to brackets

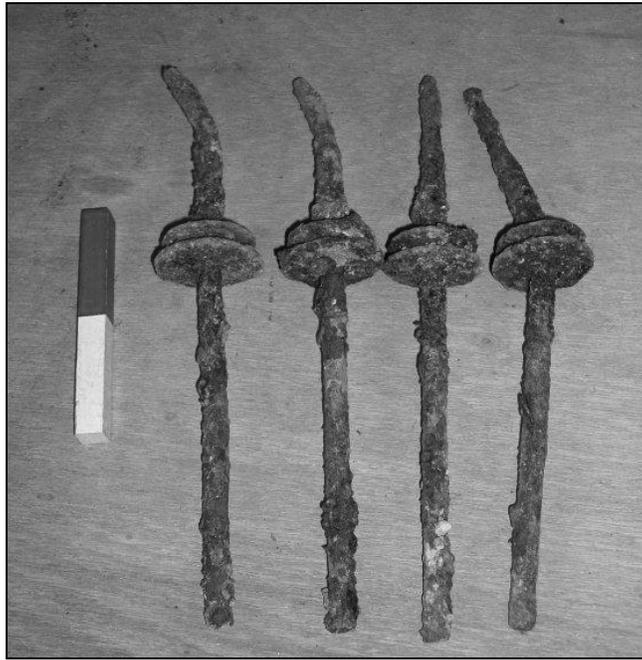
Finally, there were a very few spindles with whorls still attached (Plate 12).

Plate 12 Spindles with whorls to drive them.

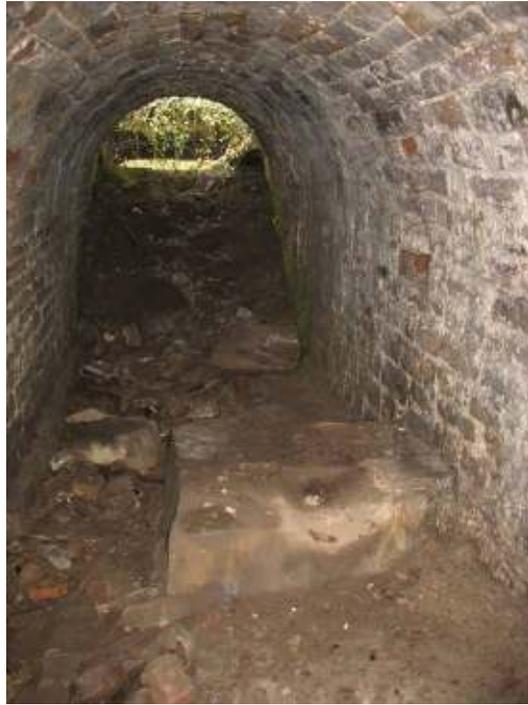
6.6 A discontinuity in the tunnel wall (southern side) suggesting that the tunnel has been altered or extended at some time. The earlier section is on the mill side. The alcove on the right of the picture is one of several in the tunnel walls.

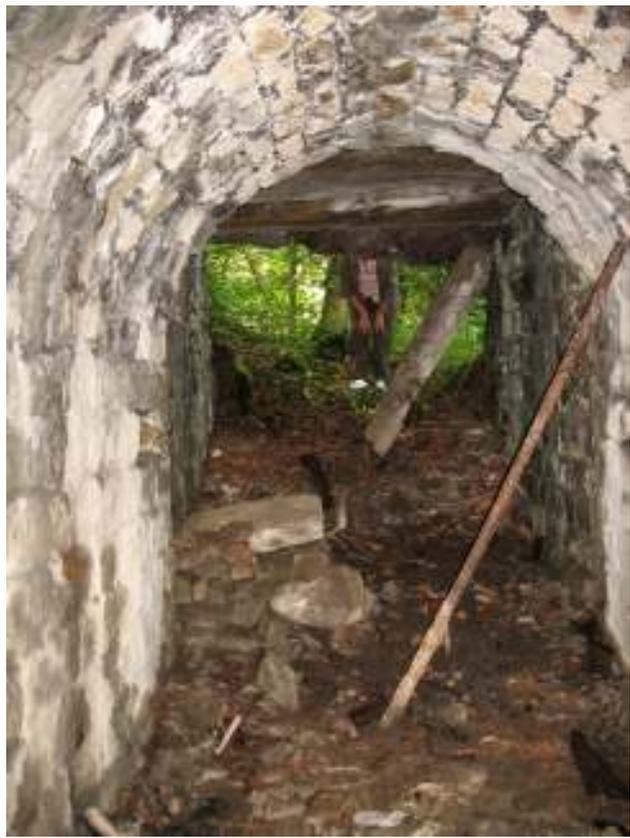
8.5 View of southern wall showing discontinuity which would relate to an extension to the west. The slope of the tunnel on the east side can be seen to change to horizontal in the coursing of the stonework.
