*An Archaeological Evaluation of
Samuel Oldknow's Mellor Mill, The Roman Lakes,
Marple Bridge, Stockport*

A report by Peter Noble and Brian Grimsditch
University of Manchester Archaeological Unit
University of Manchester Field Archaeology Centre
Oxford Road
Manchester
M13 9PL
Tel 0161 275 2313
Fax 0161 275 2315
e-mail: peter.noble@manchester.ac.uk
UMAU November 2009

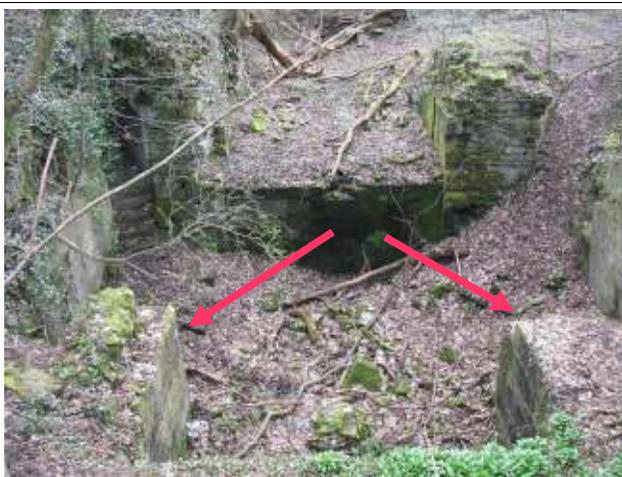
1.1 Wellington wheelpit viewed from above the tailrace. The picture is looking east. The narrower walls of the axle supports are visible in the foreground. The water would have been fed over the lip in the middle of the picture. Tunnel 11 is visible in the top left of the picture.

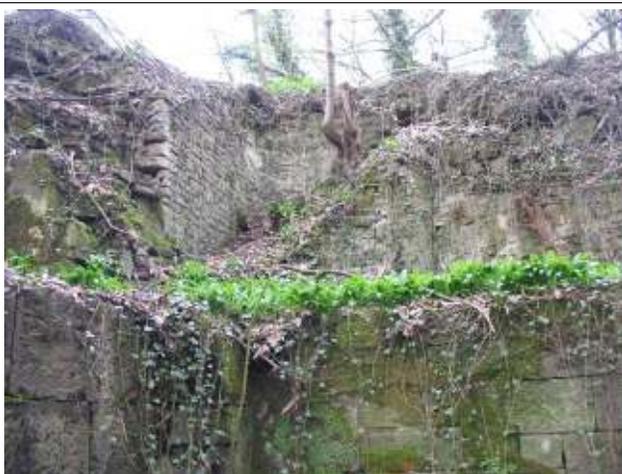
1.2 Looking out of Wellington wheelpit towards the west. The nearer wall is the wall over the tailrace arch. The further wall is probably the limit of the mill building above. There appears to be a staircase curving down into the wheelpit in the corner

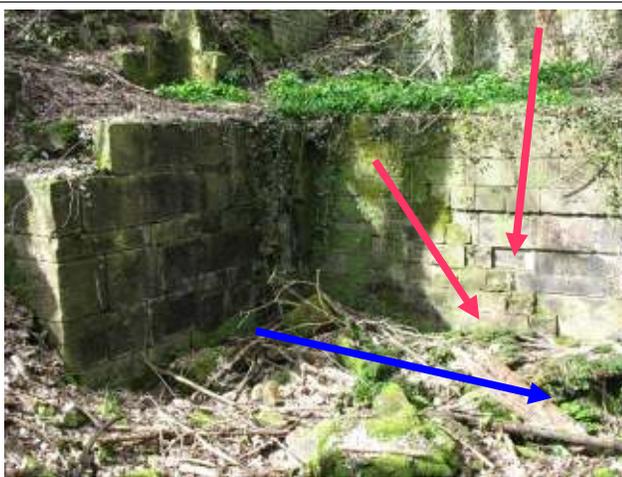
1.3 Looking west in Wellington wheelpit from the same point as the picture above. The line of a possible line of steps is visible in the facing wall (red arrow). The tailrace arch is out of sight below the debris in the foreground (blue arrow).

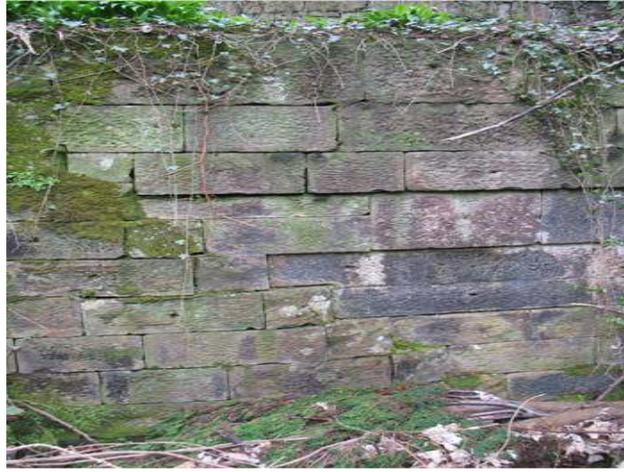
1.4 Close-up of wall above tailrace showing the apparent line of steps. At first sight, this appears to be a later addition although close examination shows the same masons' marks on both the left (apparently original wall) and right (apparently infill) of the steps.

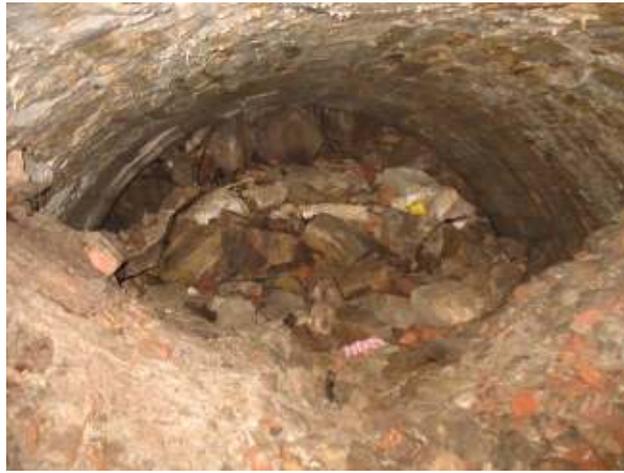
1.6 The inner side of the infilled wheelpit viewed from below. The debris infill from the inlet shafts is visible on both sides of the picture. The picture is taken looking east and represents the eastern end of feature 1.

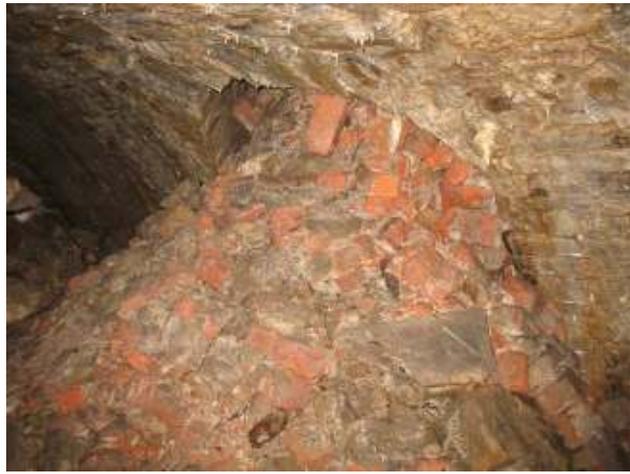
1.7 The southern inlet shaft with rubble infill. The northern inlet shaft is essentially the same.

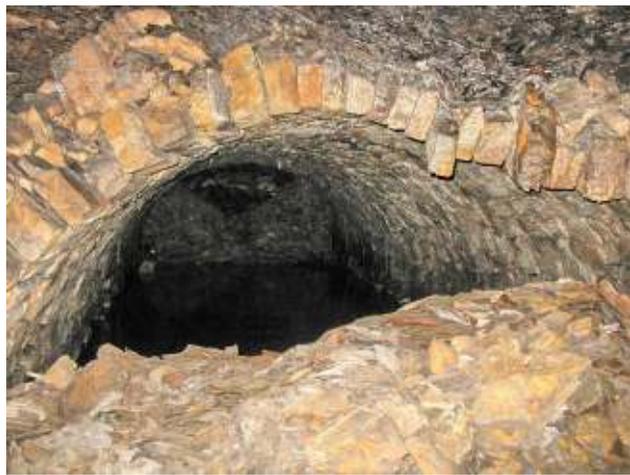
1.8 The roof fall in the Wellington tailrace viewed from the west. The inlet shafts on each side of the tunnel are just visible in this picture which has been artificially lightened.

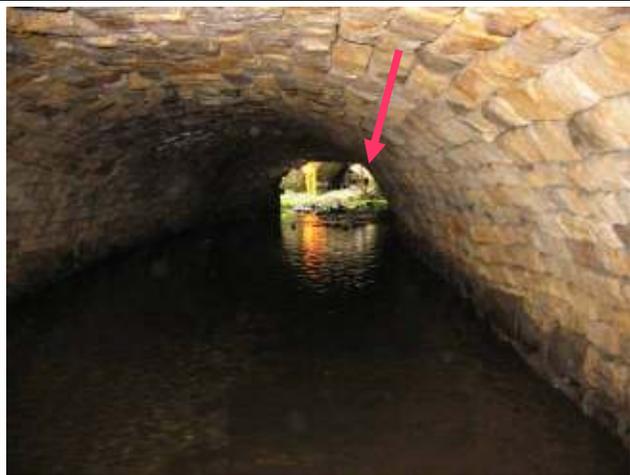
1.9 Looking west down the Wellington tailrace with the roof fall behind the camera. The passage is a good walking height in the centre but the floor is covered in mud and water. A figure is visible outside the entrance and the light from the arch of the extension (feature 3) is just visible (red arrow).

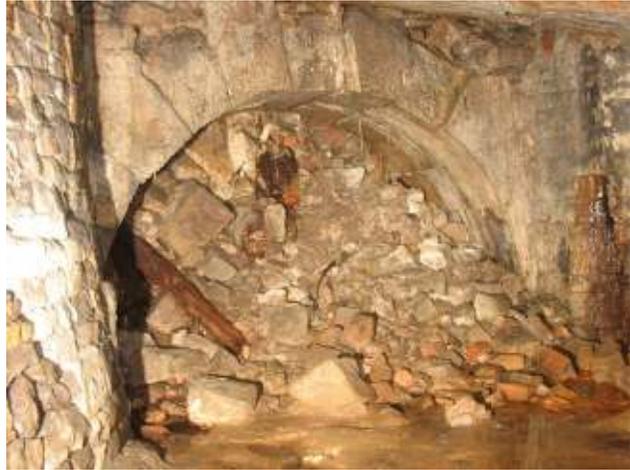
2.2 The archway at the inner end of the Southern tailrace. Note the splendid stone arching and the flat roof (just visible at top right hand corner). The curvature of the left hand wall is believed to have been formed when the tailrace was diverted north to join the Wellington tunnel.

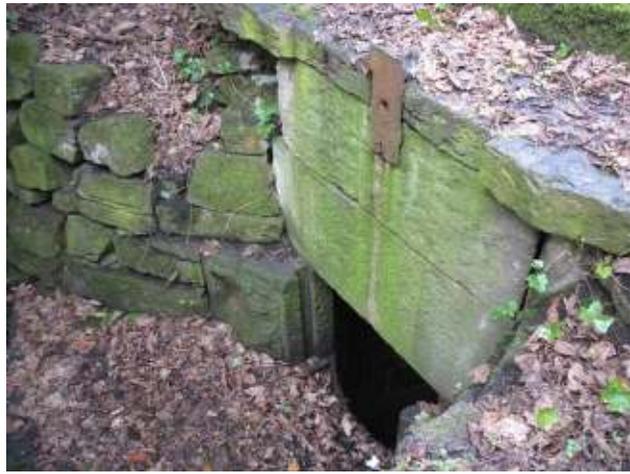
Just before the inner end is a side passage on the north west side. This starts as an excavation in solid rock and then becomes arched in stone. The purpose of this tunnel is not clear but it could have served as a point from which water could be let in to by-pass the wheel so as to keep the Waterloo wheel fed with water when the southern wheel was out of service. Where the tunnel is rock arched may correspond with the back-filled section of the original, straight tailrace. The side tunnel starts at the foot of a very neatly built circular stone lined shaft to surface which had a sluice from the bypass spillway. The groove and a small part of the mechanism of the sluice can still be seen on the surface (photograph 2.7).

2.7 Outside the entrance shaft showing signs of there having been a sluice and the metalwork required to lift it. The shaft would have allowed water from the spill way to enter the tailrace, possibly to supplement the feed to Waterloo if the Southern wheel was out of service.

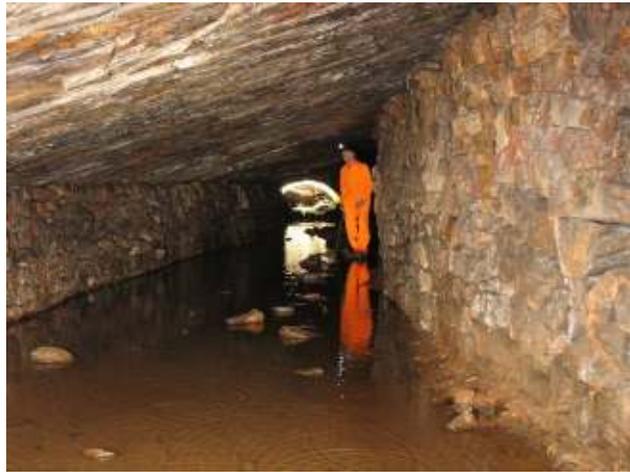
The tunnel from the outer Waterloo end runs along the strike of the bedding with a good roof of sandstone on a slope and walls of dry stone walling holding back a shale band. This structure can clearly be seen in the photographs 2.8 and 2.9. Shale has pushed down the higher (eastern) wall in places but there are no serious problems of collapse or infilling. At the inner end, the tunnel curves to the left (to the east) before coming to a substantial stone-built arch with large blocks alternately recessed to give an attractive decorative effect on inner side (not presumably visible from either side when the wheel was operating). The last curved section of the tunnel is walled on both east and west sides and roofed with stone (see photograph 2.3), supporting the theory that the tunnel originally ran straight on to the river.

2.8 Looking northwards out of the Southern tailrace. The solid sloping roof can clearly be seen. The walls hold back shales. Note the right hand wall which is curved by the realignment of the tunnel towards Waterloo.

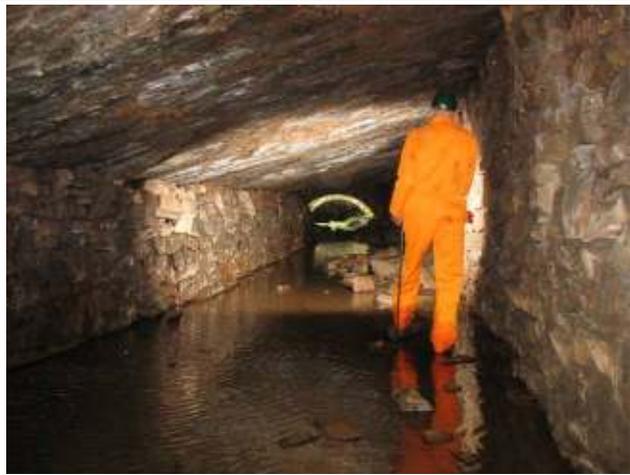
2.9 Another view in the Southern tailrace. The curved section in the distance is the arched entrance.

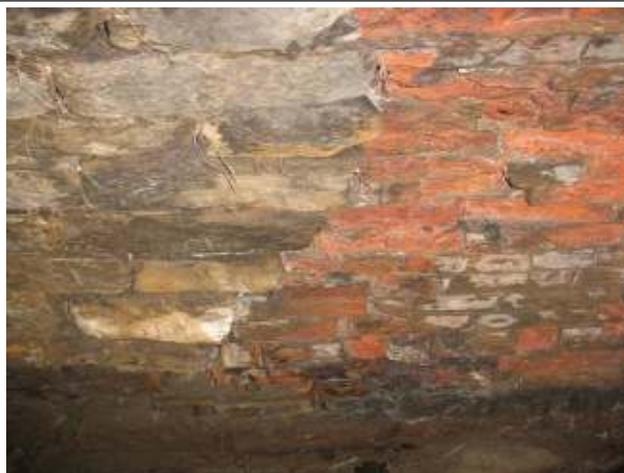
3.2 The point in the tailrace tunnel where stone (upstream) joins brick (downstream). It is possible that the brick section was covered over to make more room for the riverside buildings.

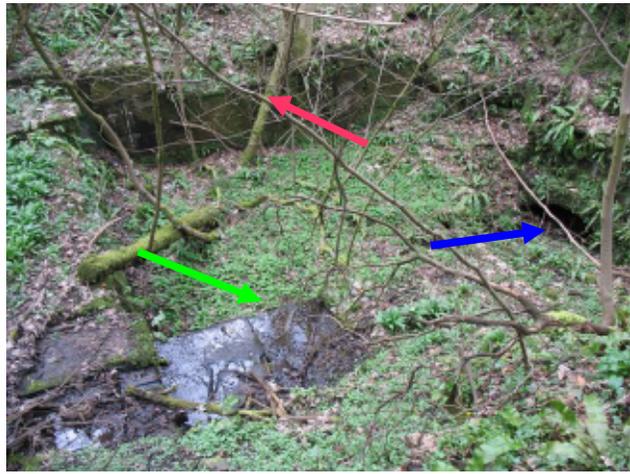
4.4 Looking down on Waterloo wheelpit. The southern bearing is indicated by the red arrow and the northern bearing by the green arrow. The tailrace arch, feature 4, is in the centre right (blue arrow). The platform between the photographer and the northern bearing was probably a water spillway.

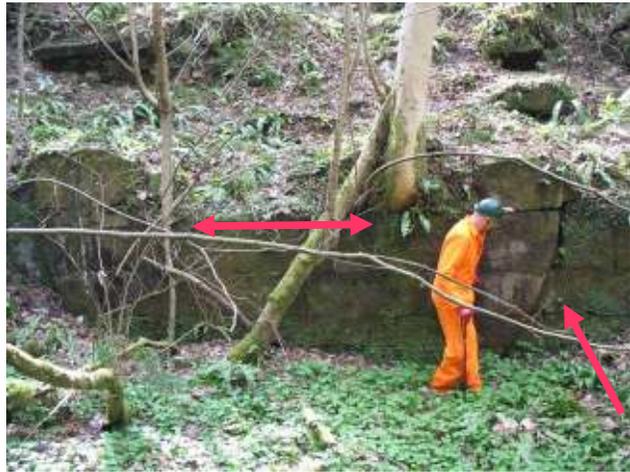
4.5 The southern side of the wheelpit. The bearing block is indicated by the arrow. The curved line around it has been carved out of the stone wall and might indicate a need to widen the pit at some time, possibly to extend the gear ring on the wheel.

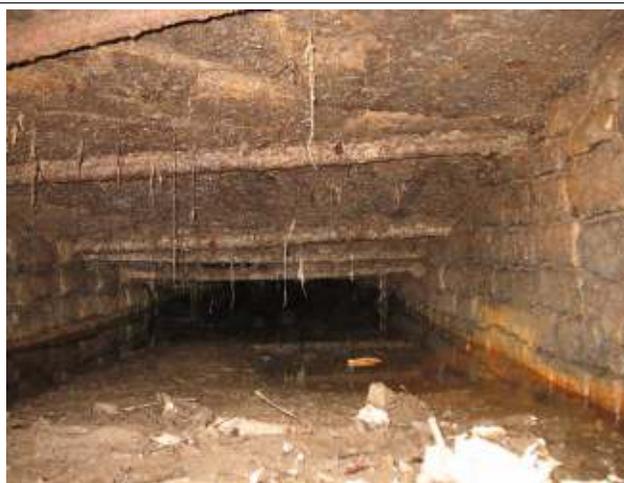
4.8 Inside the first section of the tailrace showing the flat roof and the supporting iron bars. The limit of the view is about 3 m in front of the camera and is about 150 mm high by 2 m wide at the most. The water on the floor makes judging heights difficult. Further exploration would involve getting very muddy. The slope down of the roof can be judged from the coursing of stone in the right hand wall.

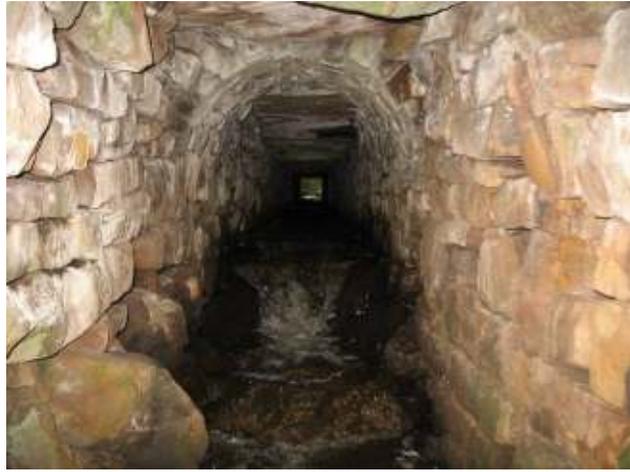
5.2 Looking eastward up the culvert from the river end, the roof can be seen to be slabbed, arched and then slabbed again. The arching may represent an old track parallel to the river before the stream was fully culverted.

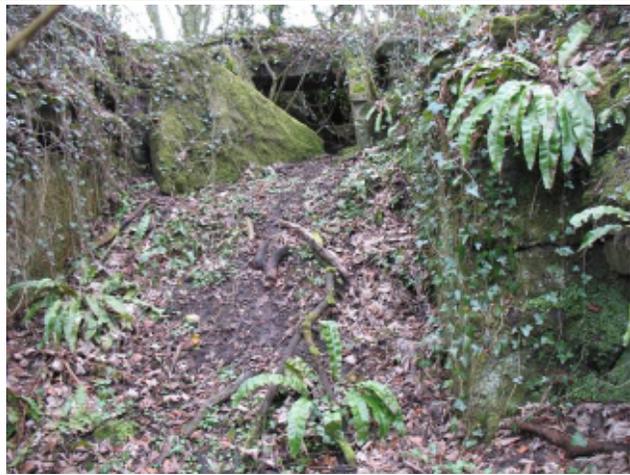
6.2 Inner (eastern) end of the drive shaft tunnel infilled with demolition rubble from the mill. The clean stone arch at the end of the tunnel can clearly be seen.

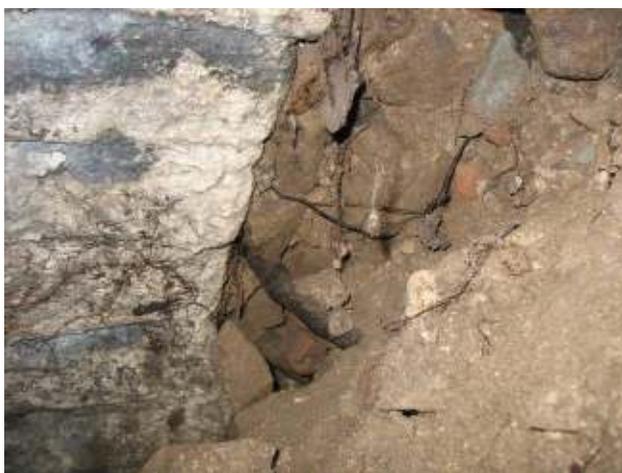
6.3 Looking out from the end. The soil on the floor has come down the manhole on the left (see picture 6.4).

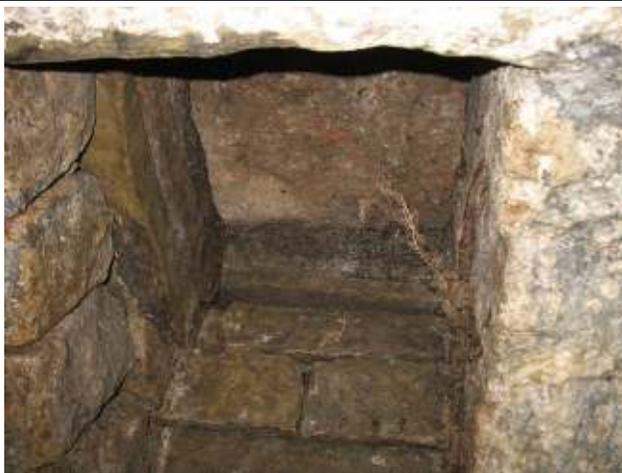
6.5 Looking east and out of the tunnel. The tidy cross section can be clearly seen as well as the bearing block on the floor which has a semi-circular cut-out at the nearer end.

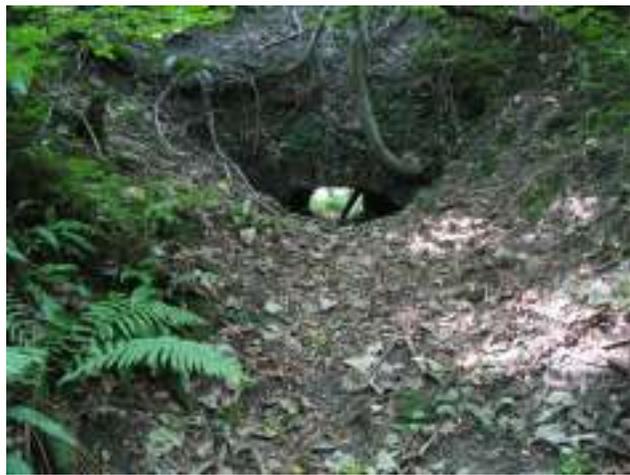
8.2 View from west to east through drive tunnel.

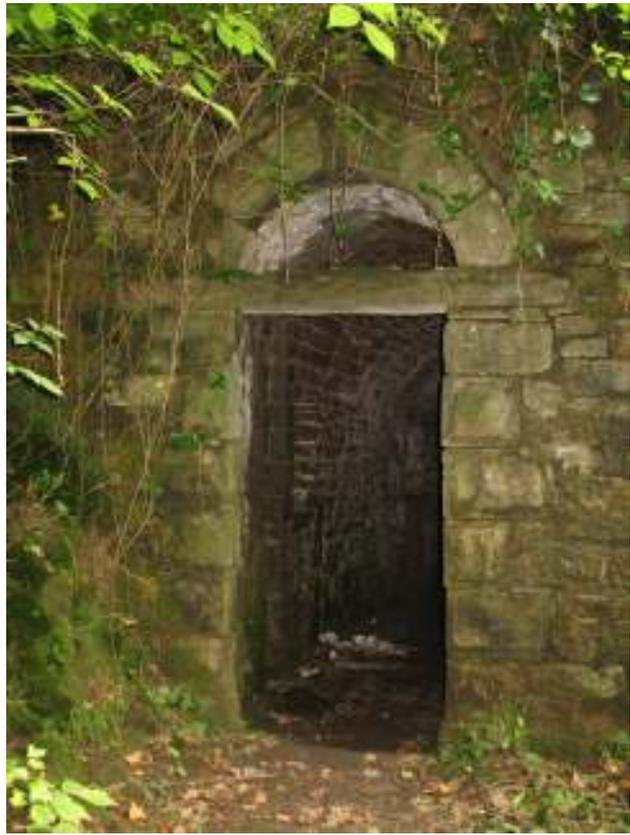
10.2 Main cellar passage looking out (northwards). There are shallow steps on the floor about 3 m apart. This would make it accessible by horse if required. Note the blind arch on the right and beyond it a blind rectangular recess in the wall of which there are at least two on each side.

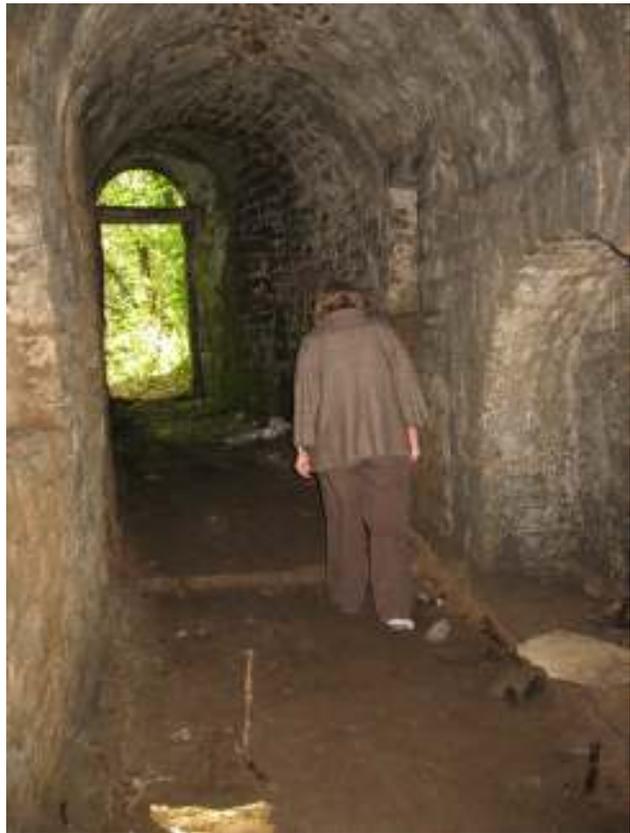
10.3 The way into the end rooms of the cellar which have been filled with soil. Another room is accessible on the right hand side at this point.

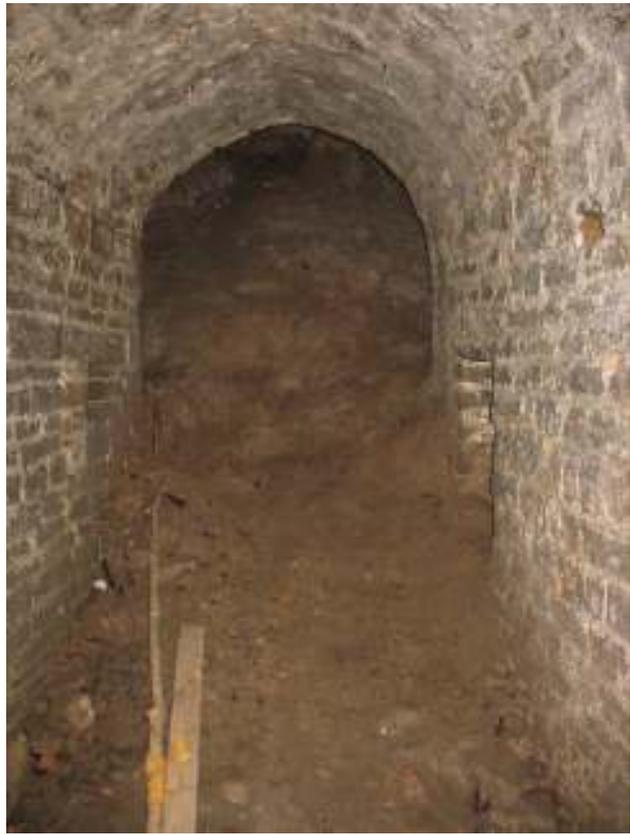
10.4 The east side passage. It appears to open into a chamber filled with a circular stone built feature. Could this have been a circular stairway from the house above? A more detailed map of the tunnel is required to establish whether this is possible. The floor of the passage at this point is covered with broken nineteenth and early twentieth century pottery.

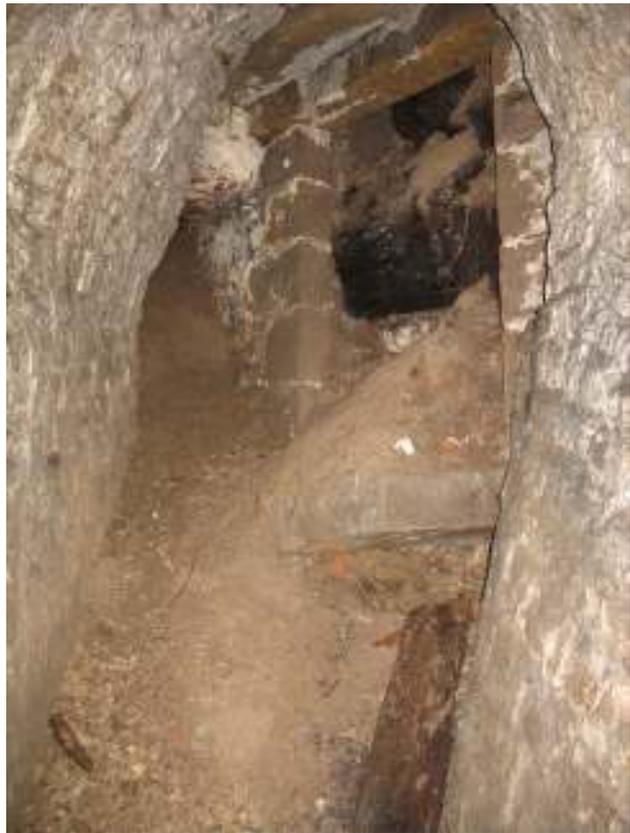
11 The Wellington wheelpit access tunnel, feature 11, is a short tunnel with steps into the wheelpit. It may have served to provide access from the wheelpit under the building to the controls of the water feed sluices by the mill lodge.

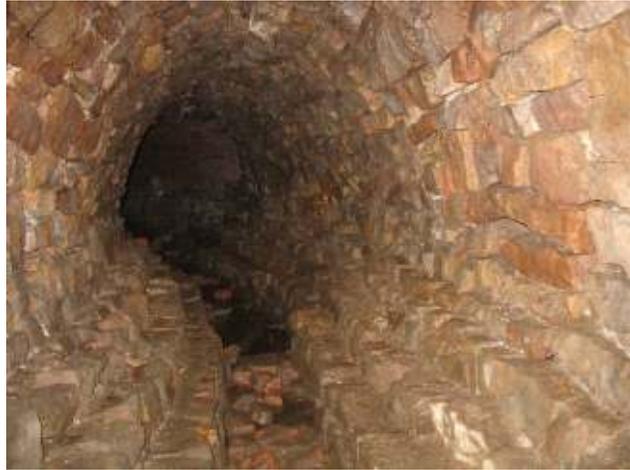
12.2 Near the end is a branch on the right leading to a partly closed entrance with daylight entering. This is presumably one of the inlets to the drain.

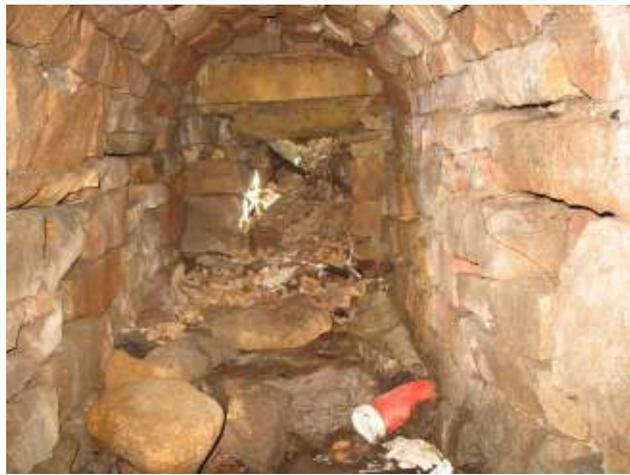
12.3 The section before the end is brick arched, possibly where it runs close to the building or the road. The picture is taken looking downstream.

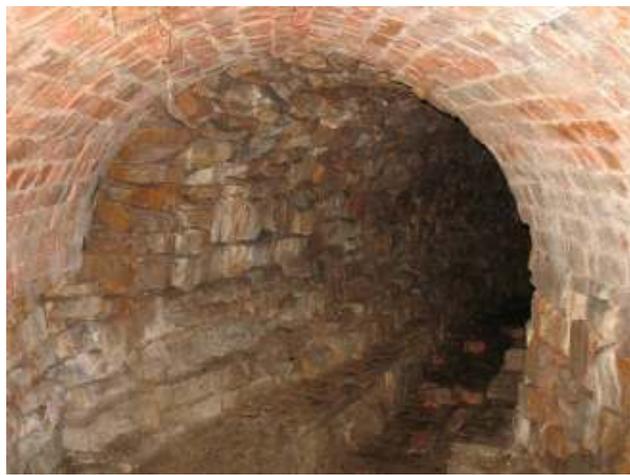
12.4 The end of the drain is in debris, probably from the mill.

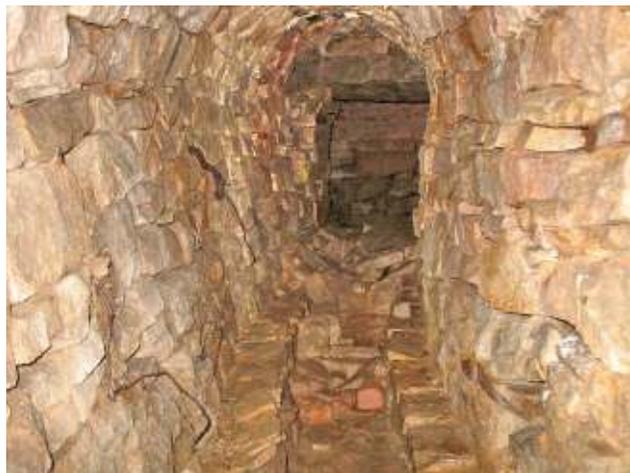
13.1 The northern drain, feature 13, runs downstream from the point where it is intersected by the drive shaft tunnel, feature 6, just west of the road. The tunnel is oval shaped and dry stone walled. It bends left, then right and then left again. Shortly before the end, there is a right hand branch that heads back towards the mill,

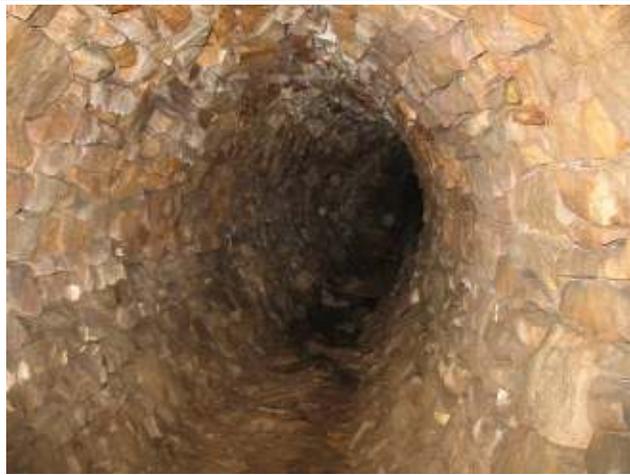
13.2 The downstream end of the drain breaks surface. It may have continued as a surface channel from this point which was probably chosen to ensure that water did not invade the workshop area.

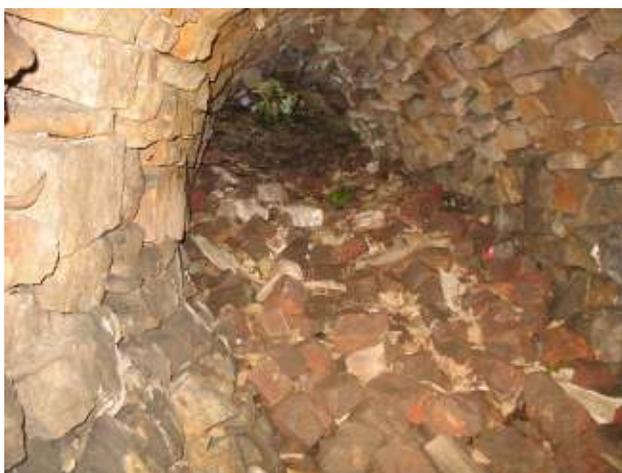
13.3 The right hand branch tends to have a flat floor. At the point illustrated, a manhole in the right hand wall has allowed soil to run into the drain.

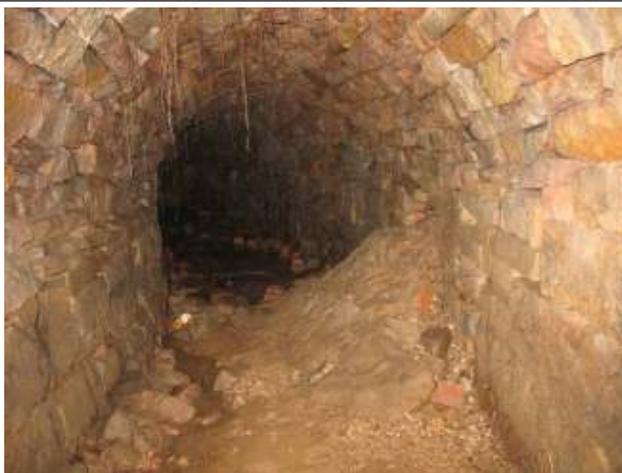
13.4 The floor of the northern drain is not stepped but is covered with large flat stone slabs as seen in this photograph.

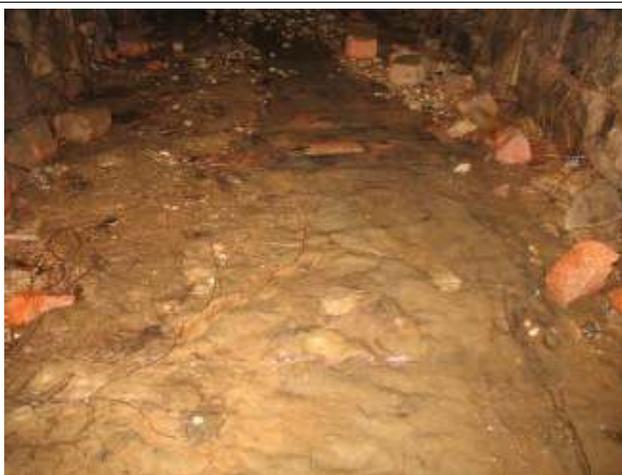
13.5 Near the end of the drain, it is brick arched.

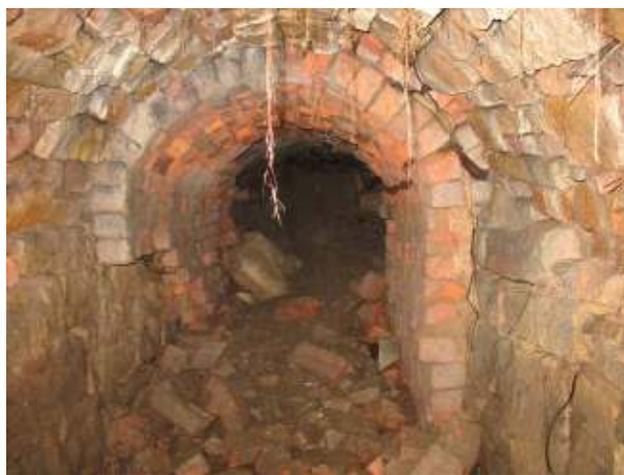
13.6 End of the drain filled with soil and bricks. A large tree root has invaded the drain.

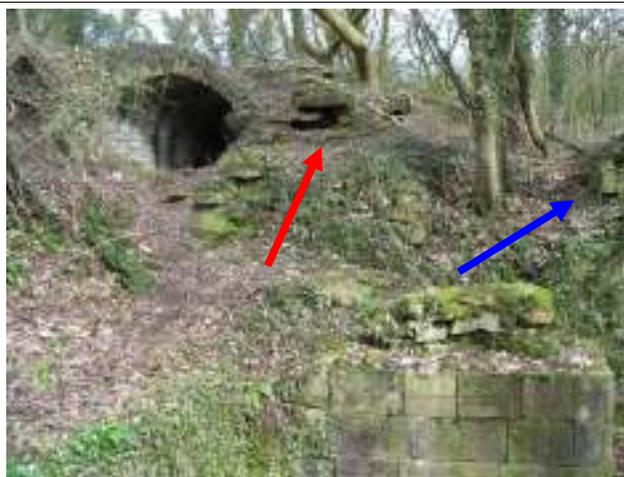
14.2 Northern culvert from above.
